# Diversified Contracting LLC

As per your request, I have inspected the roofs at the above building. The following are my findings:

**Old CVS Store (approximately 10,000 sq/ft)**

**Kroger Store (approximately 62,000 sq/ft including front extensions)**

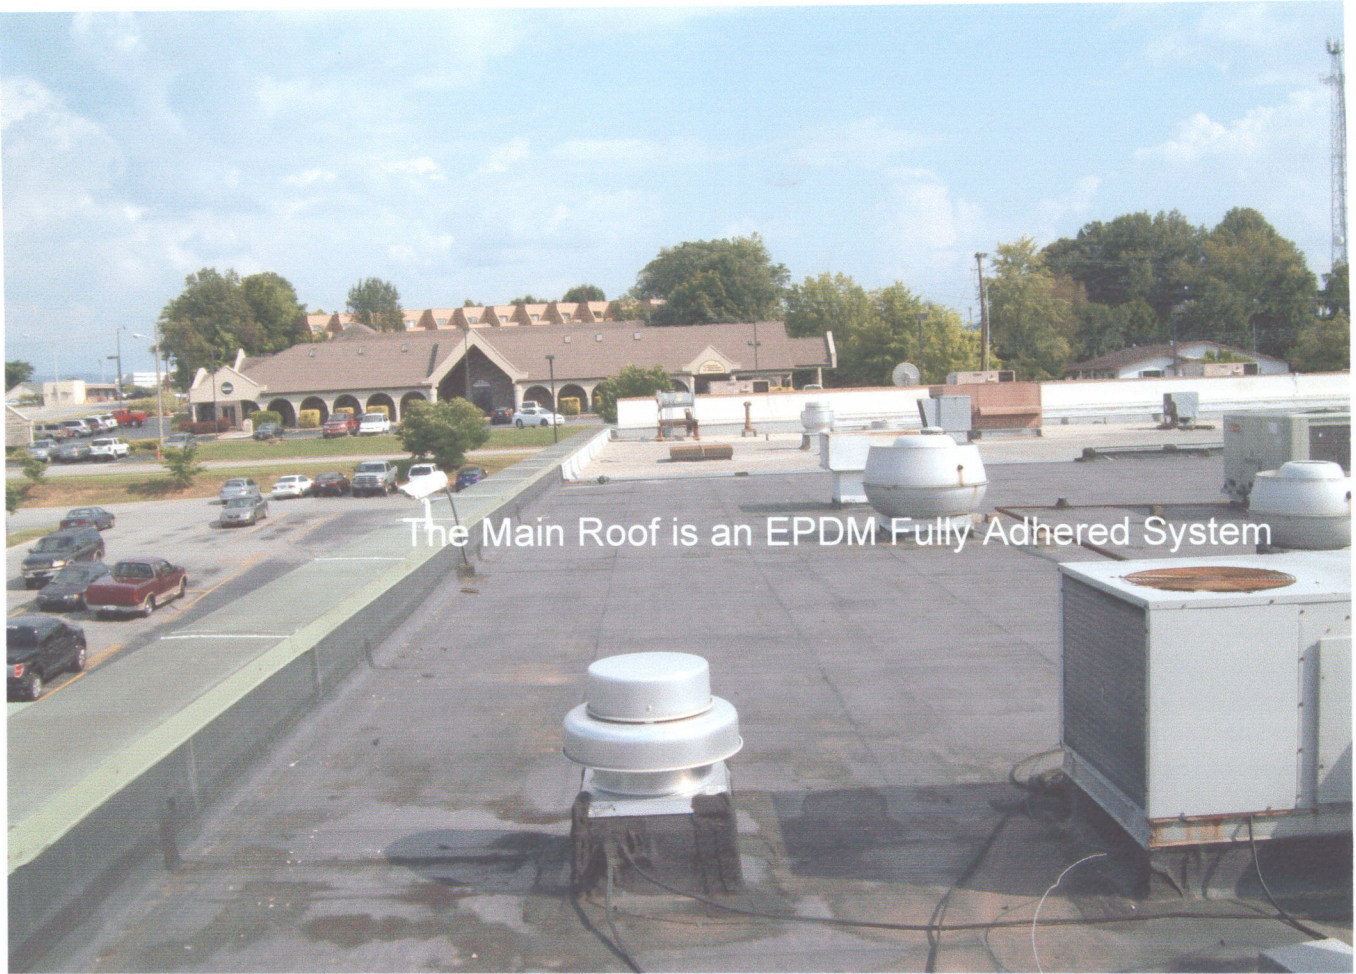
- (2) On the main section of building (approximately 42,658 sq/ft) there is an EPDM Fully Adhered Roof System which I estimate is about four to eight years old.

The Main Roof is an EPDM Fully Adhered System

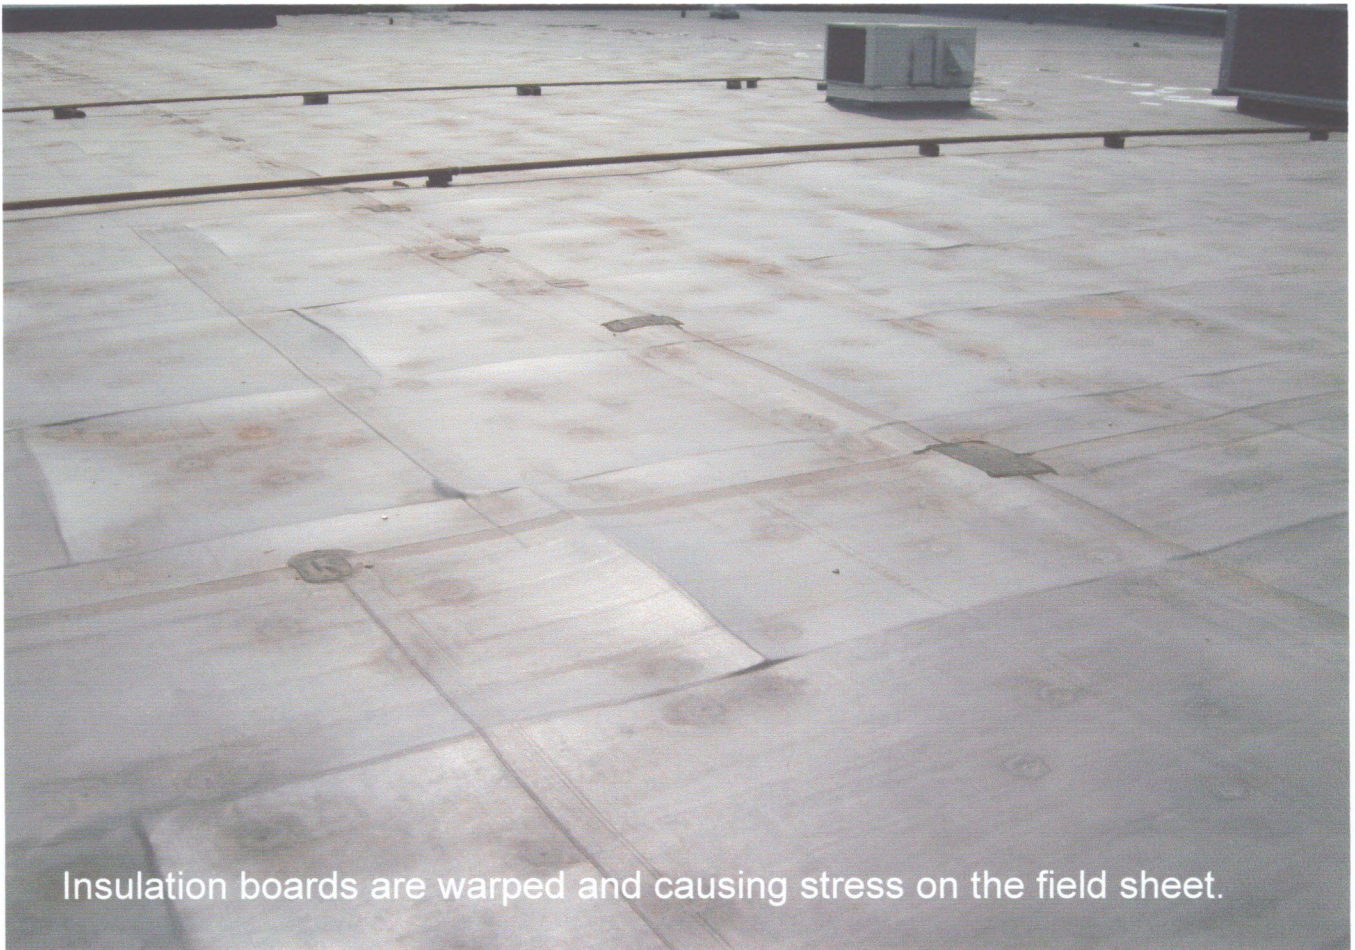
- (a) The workmanship if the roofing applicator is of good quality.
  - (b) The EPDM roof has a base layer of Poly ISO roof insulation which has curled or warped at the end laps.

- (d) It is my opinion that the roof insulation will not shrink or curl any more than it has and does not pose an immediate threat to the performance of this roof. However, it is causing some stress on the membrane surface which will shorten the service life of the roof itself.

Insulation boards are warped and causing stress on the field sheet.

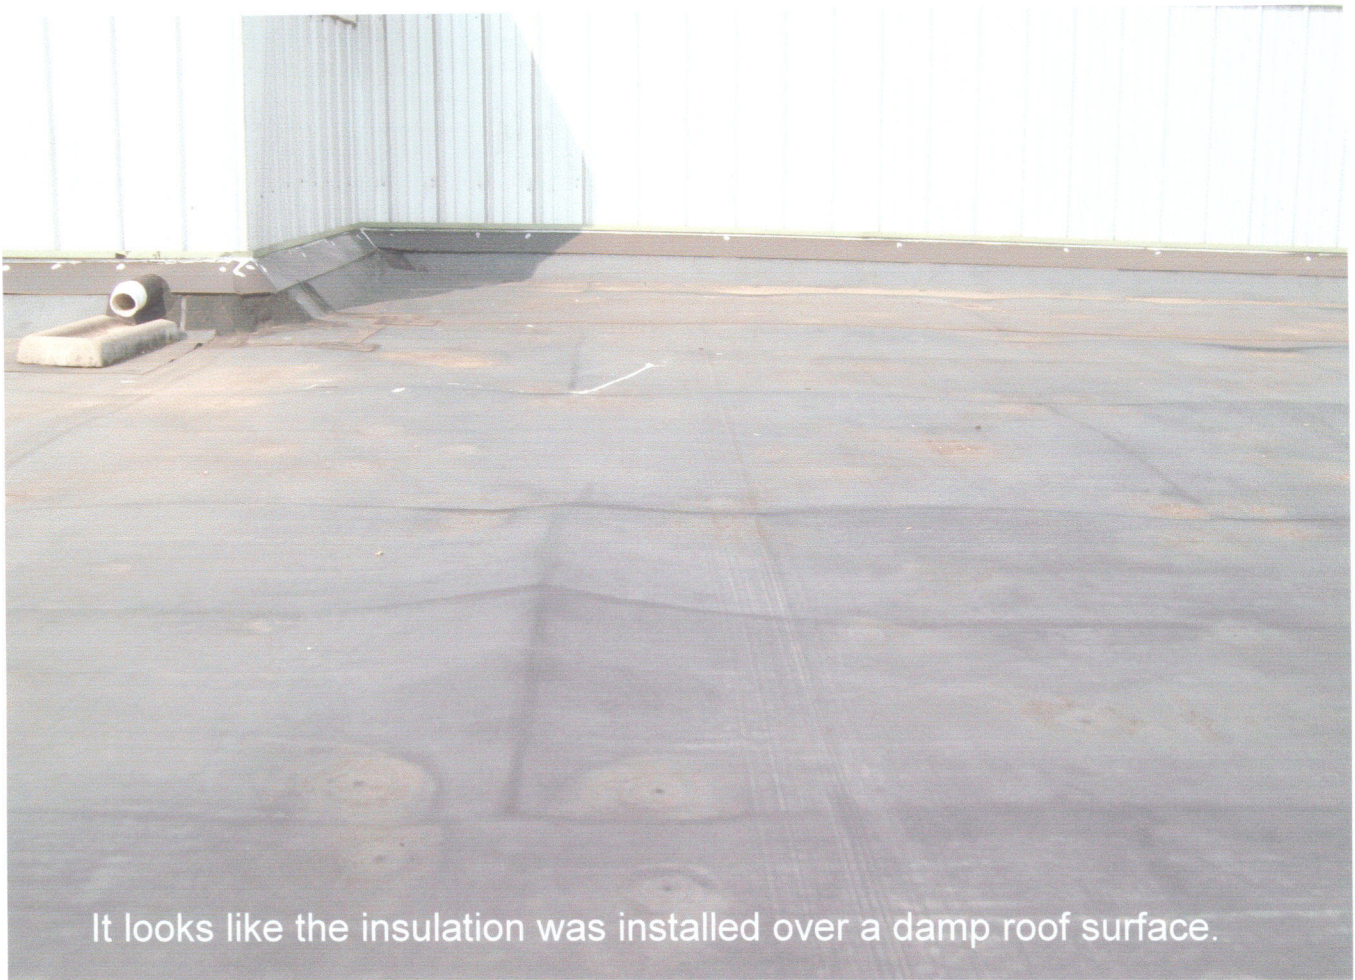
- (c) The two causes for the insulation to warp or curl under the roof system is improper storage before the insulation was installed, or that the insulation was installed over the existing gravel roof which was damp.

It looks like the insulation was installed over a damp roof surface.

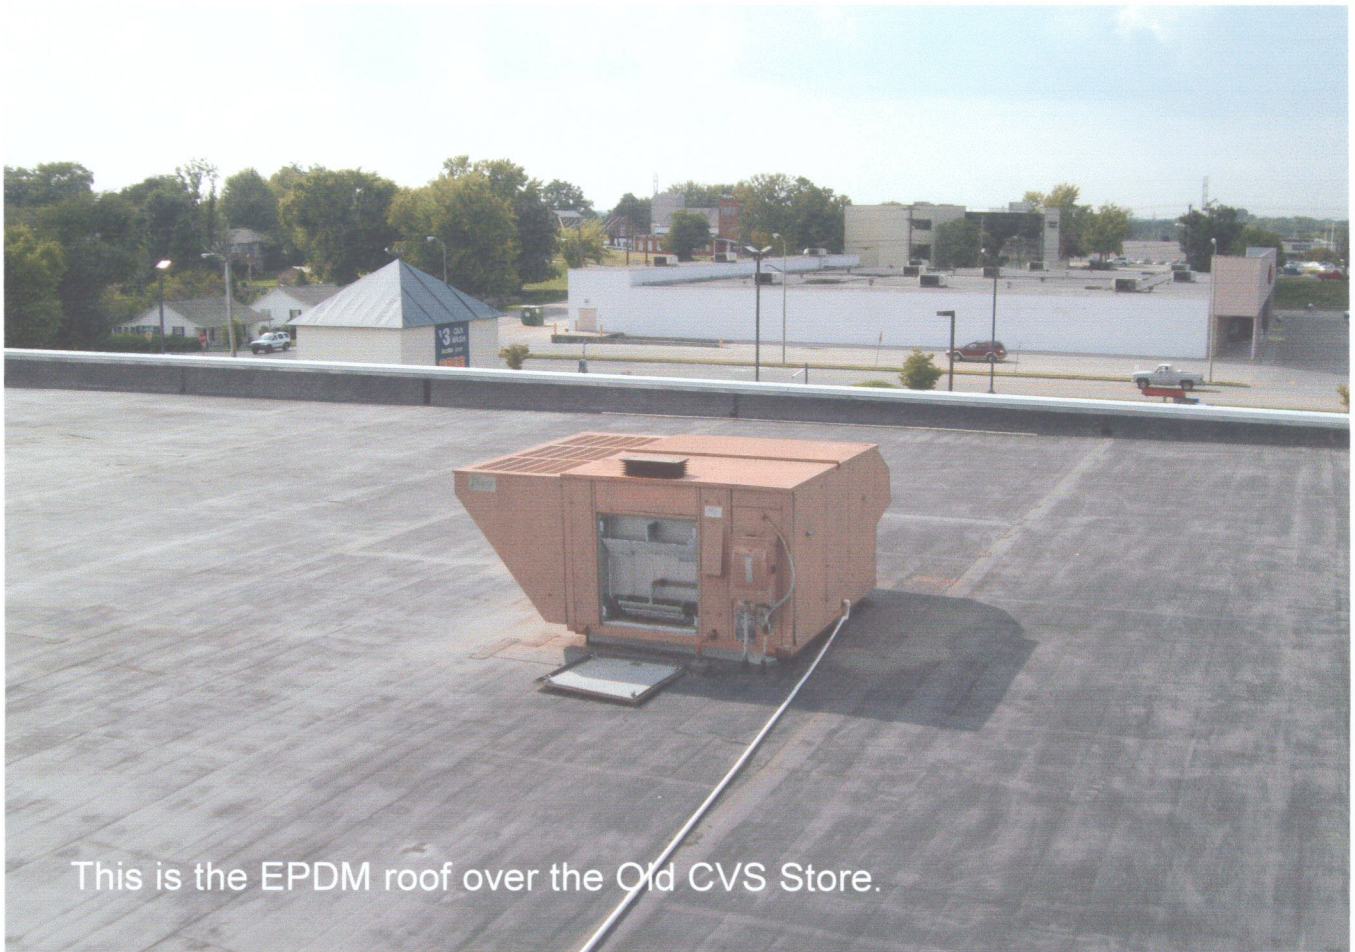
This is the EPDM roof over the Old CVS Store.

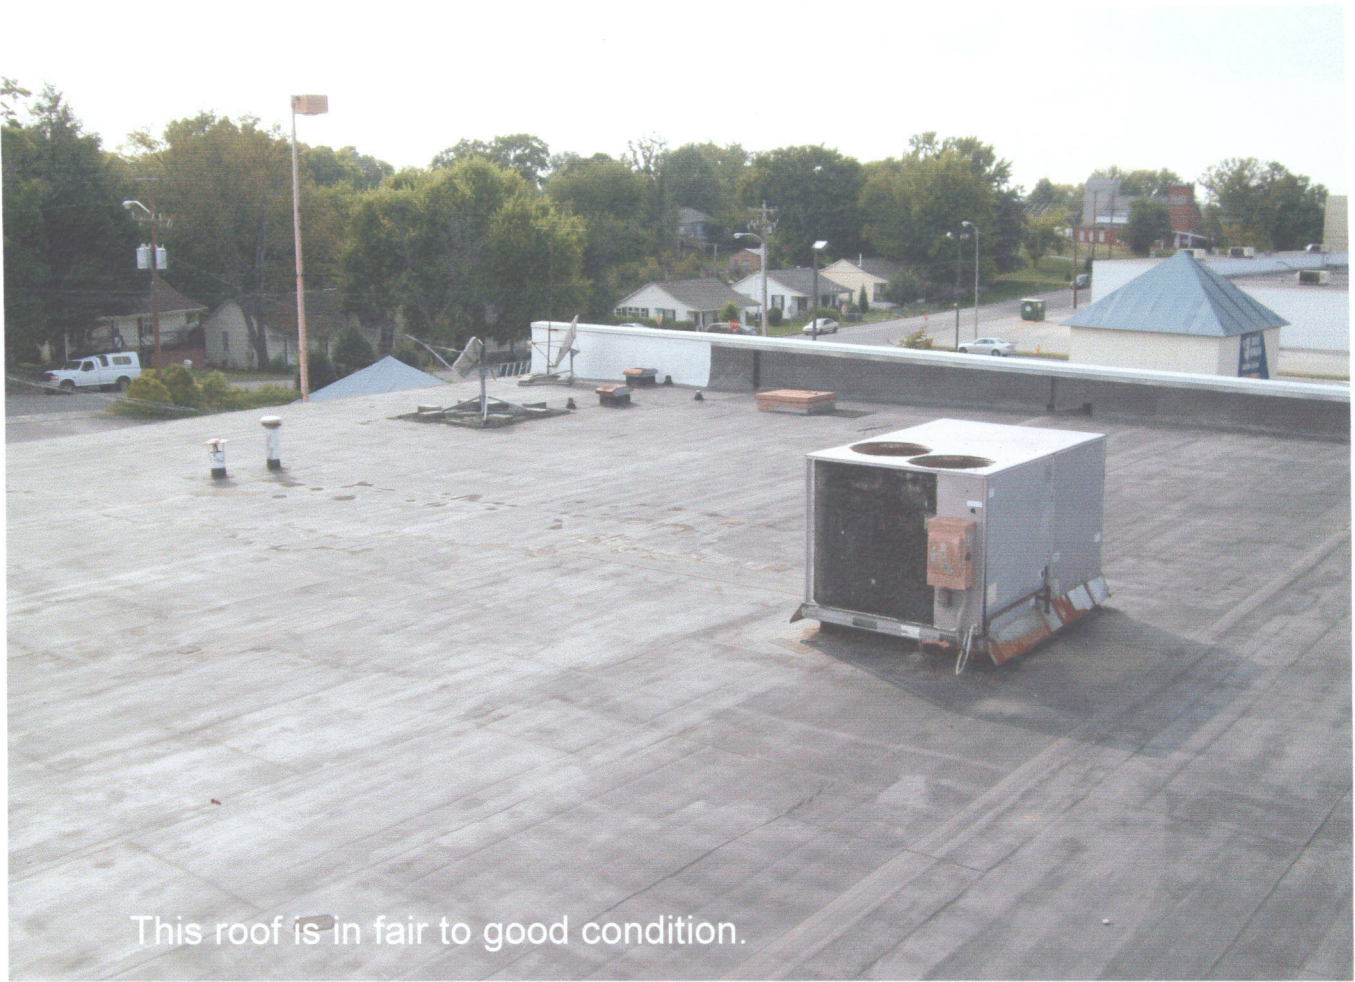
This roof is in fair to good condition.

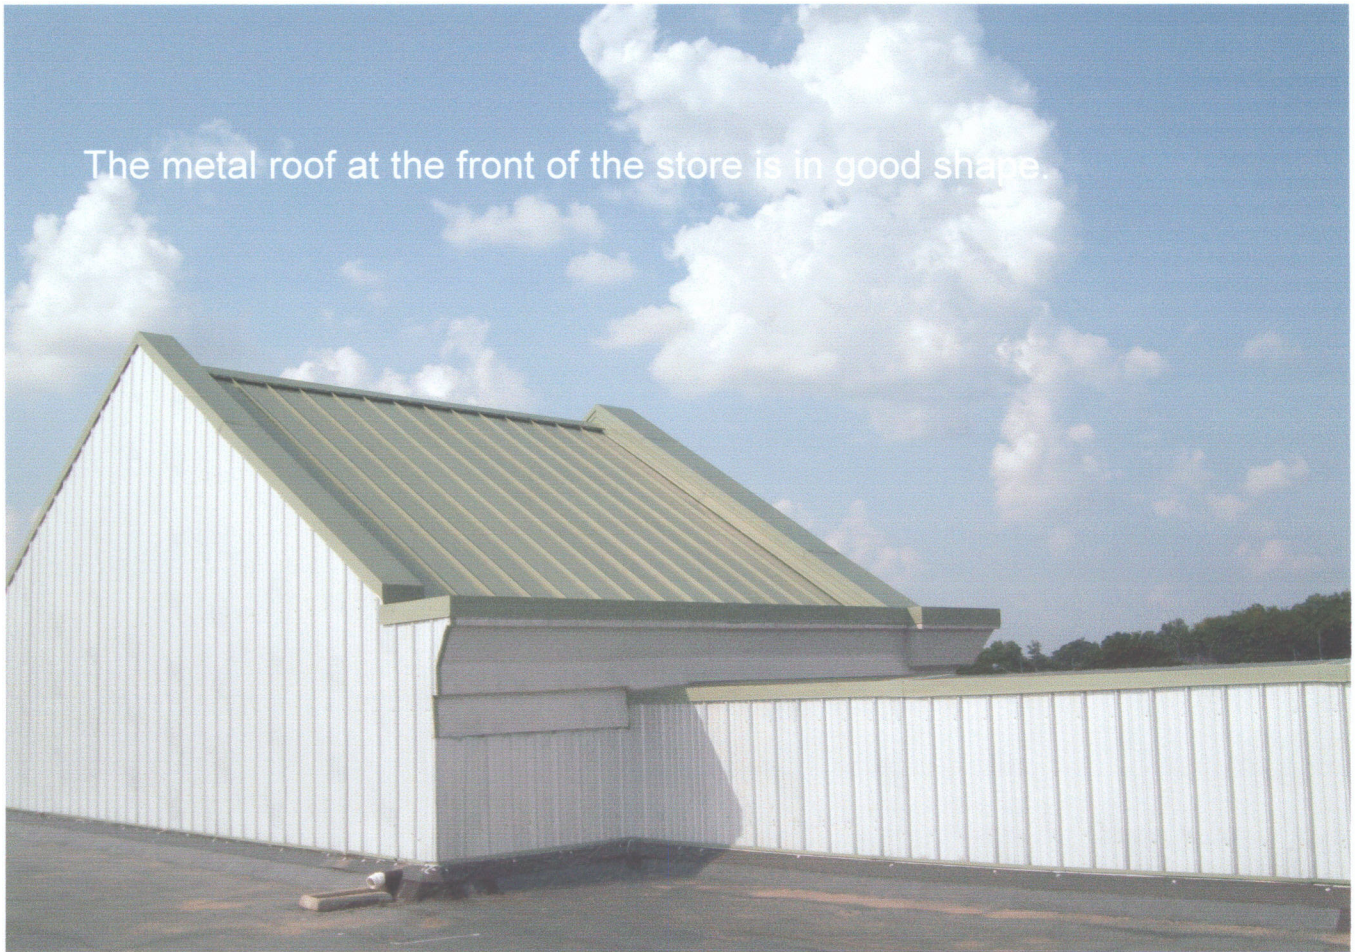
The metal roof at the front of the store is in good shape.

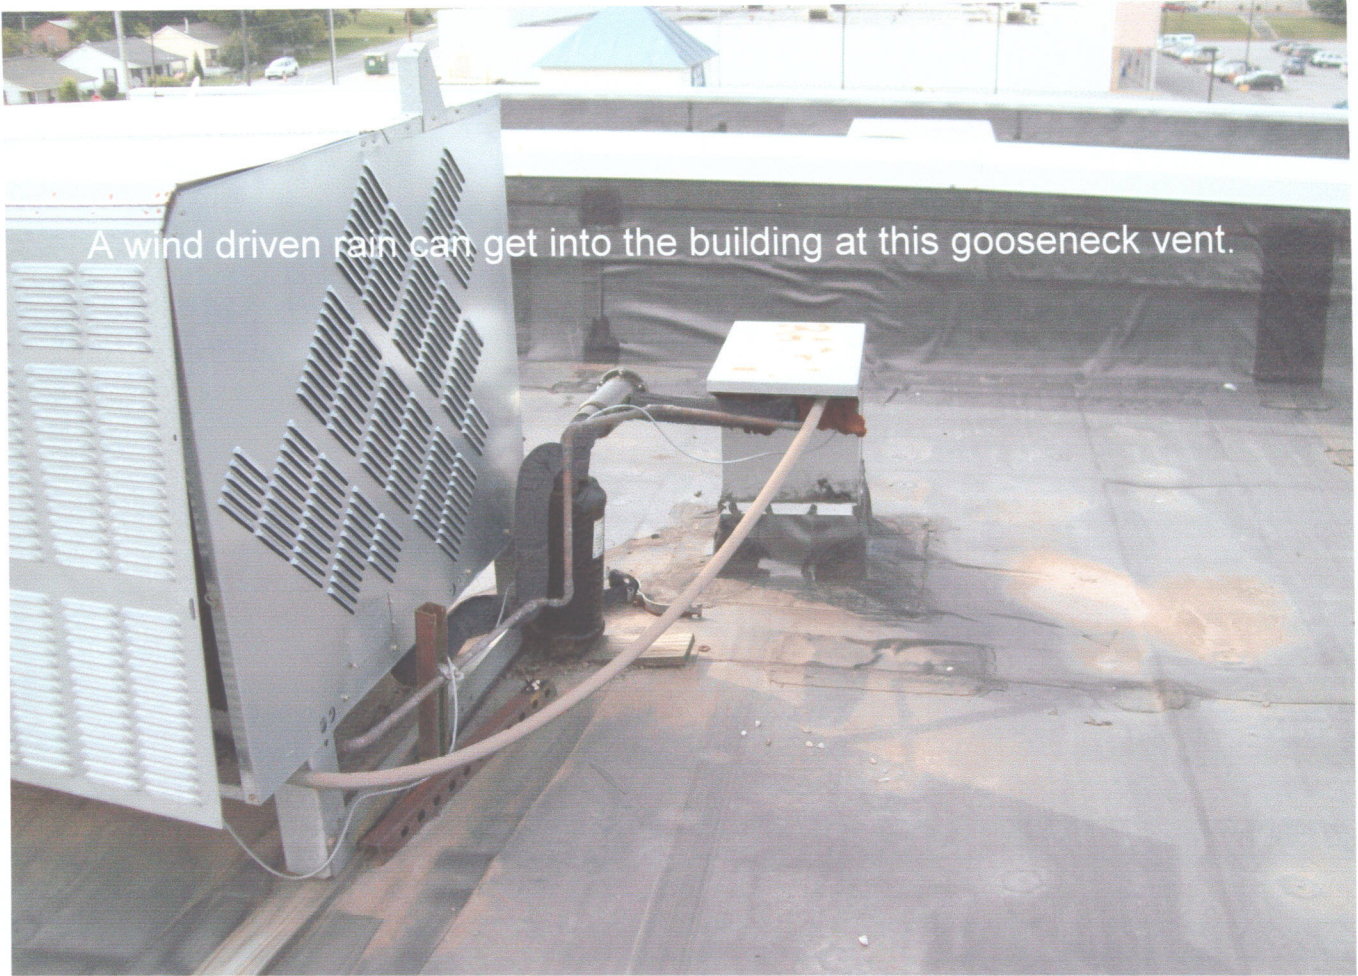
A wind driven rain can get into the building at this gooseneck vent.

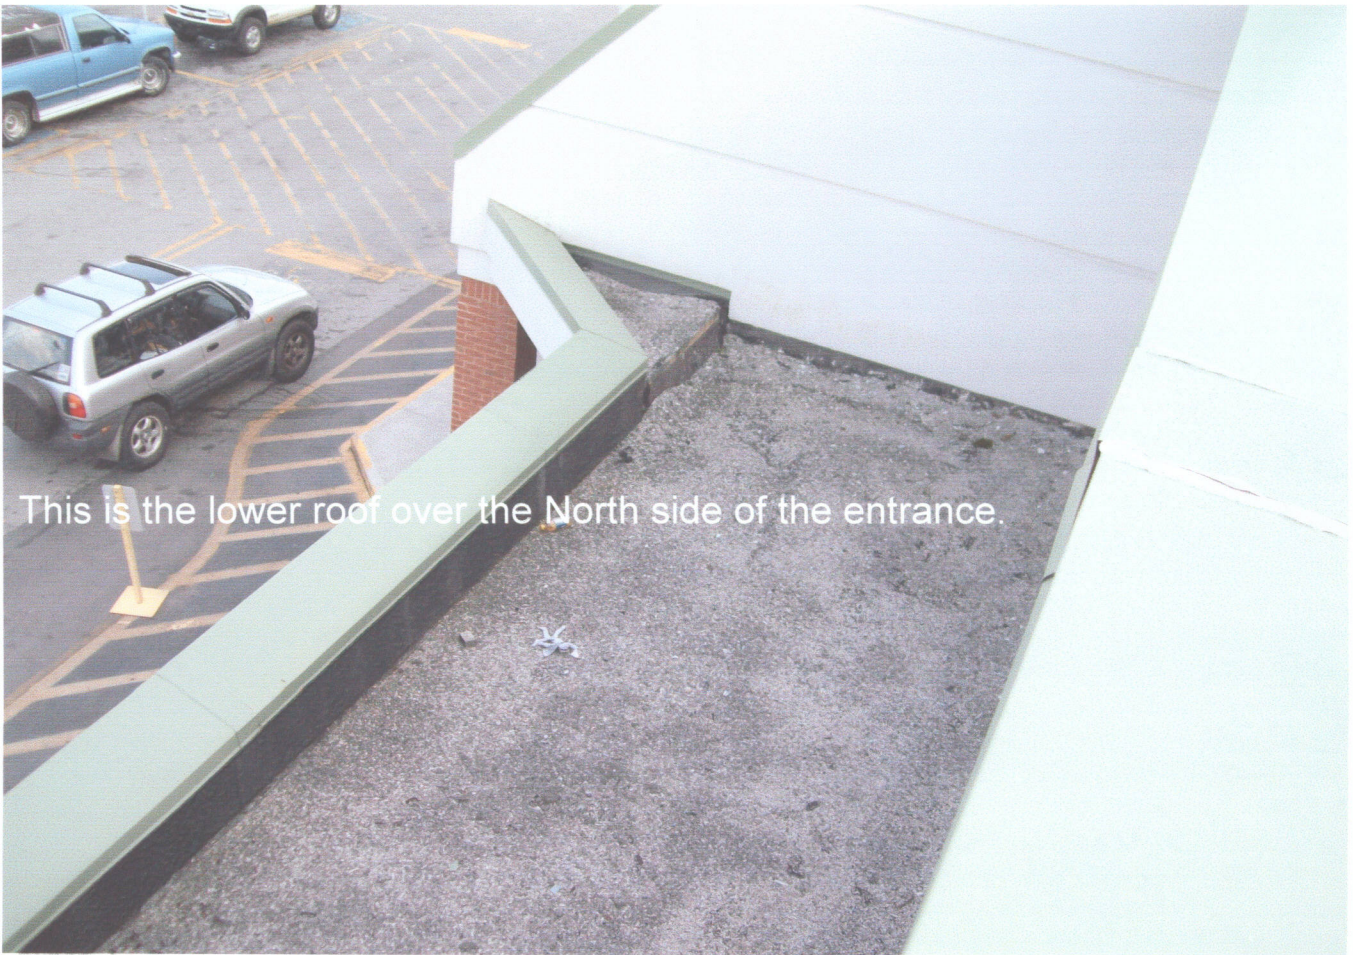
This is the lower roof over the North side of the entrance.

Wall flashing joints need to be re sealed.

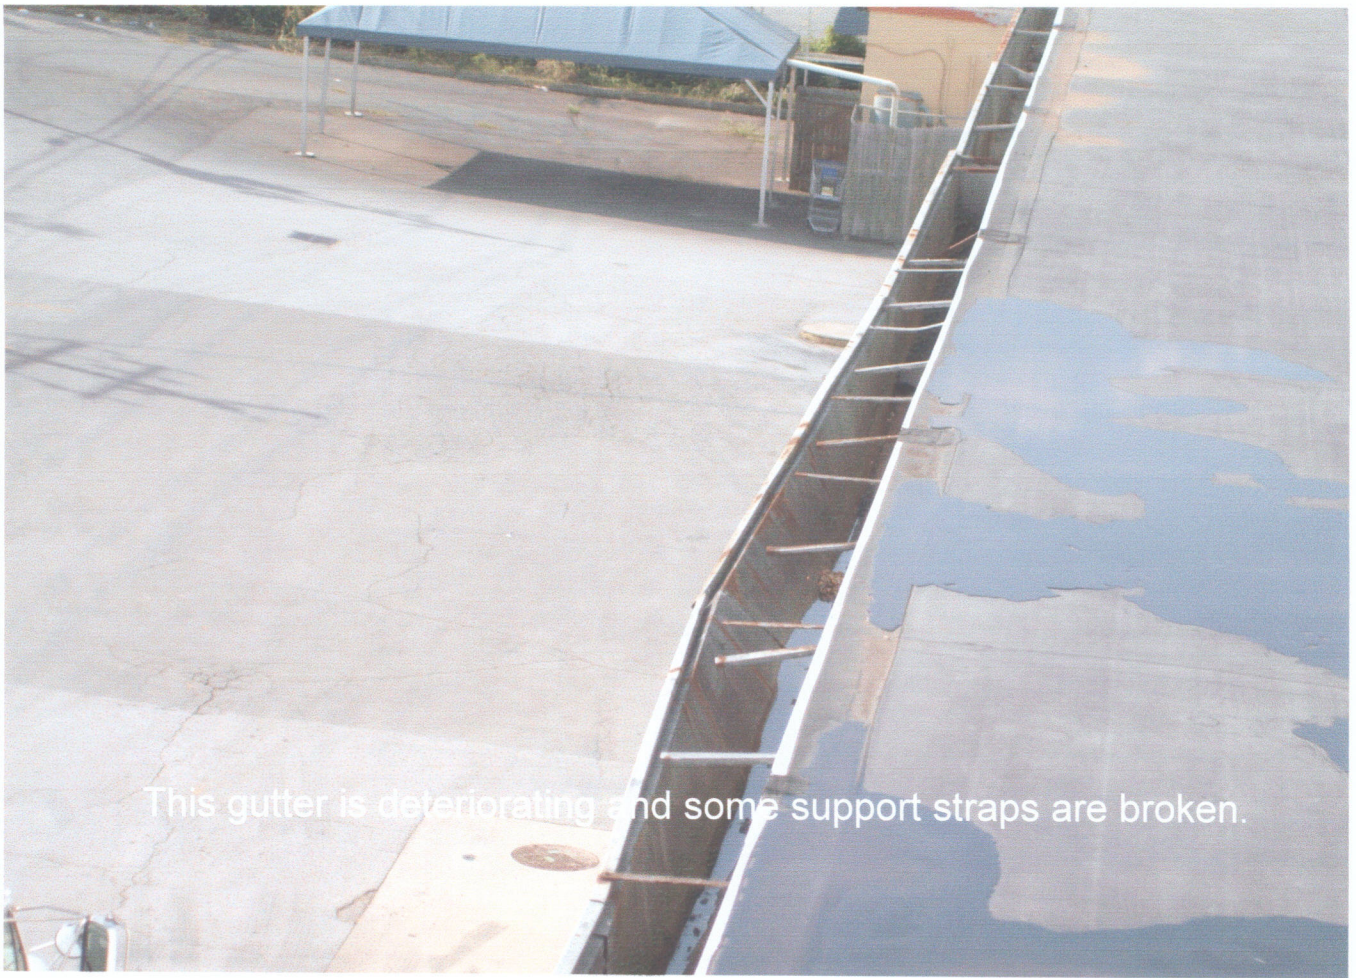
- (e) The gutters on this section of the building are deteriorating and should be replaced in two to four years.
  - (f) The owner should expect to replace this roof system in four to eight years at a cost of \$214,000 - \$256,000.

This gutter is deteriorating and some support straps are broken.

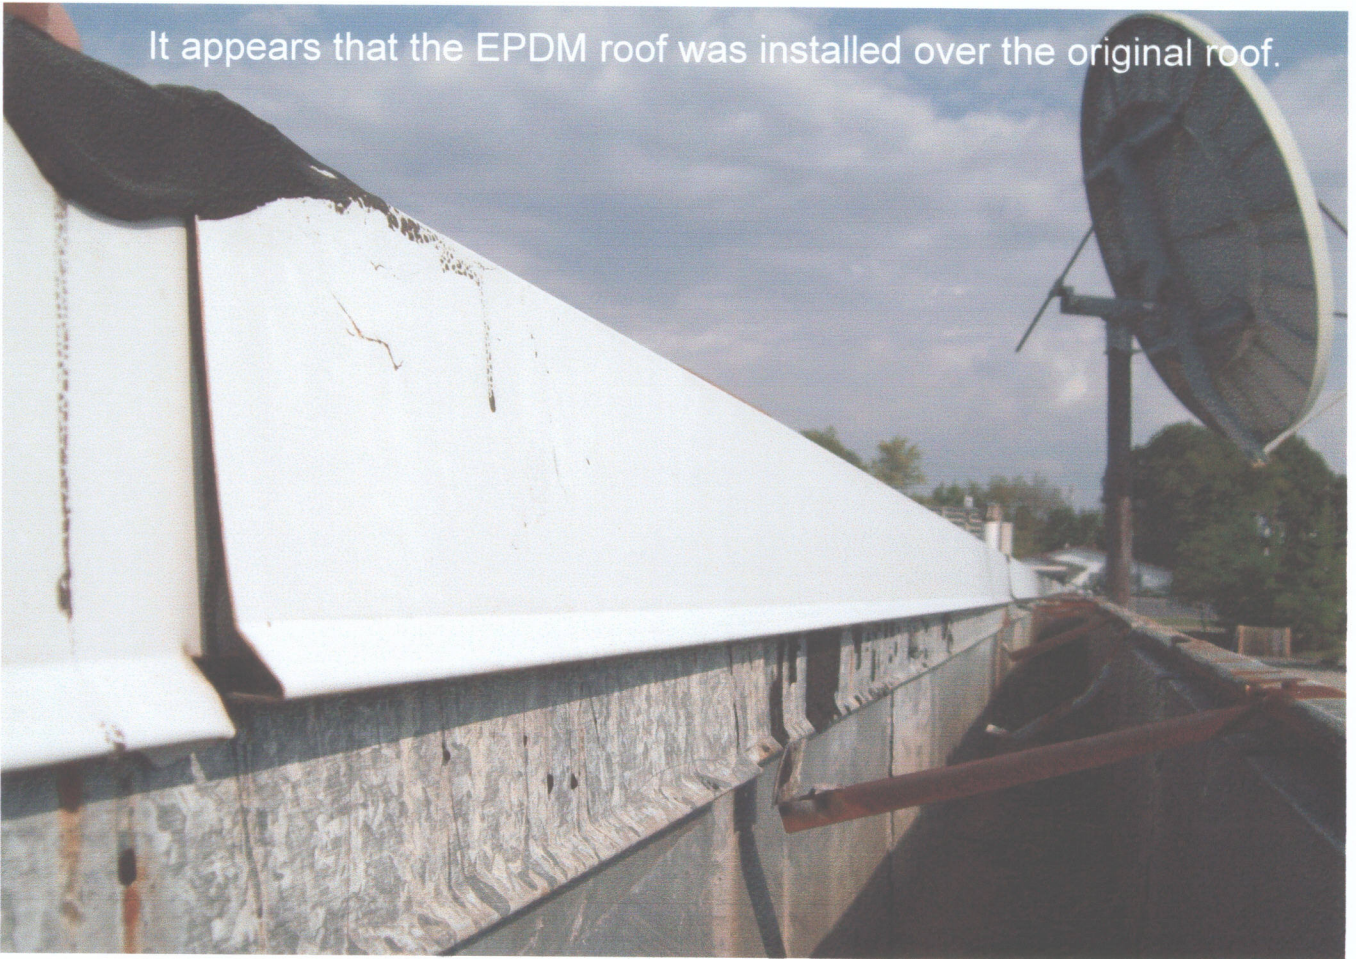
It appears that the EPDM roof was installed over the original roof.

This wall on the gravel roof is cracking and needs to be sealed.

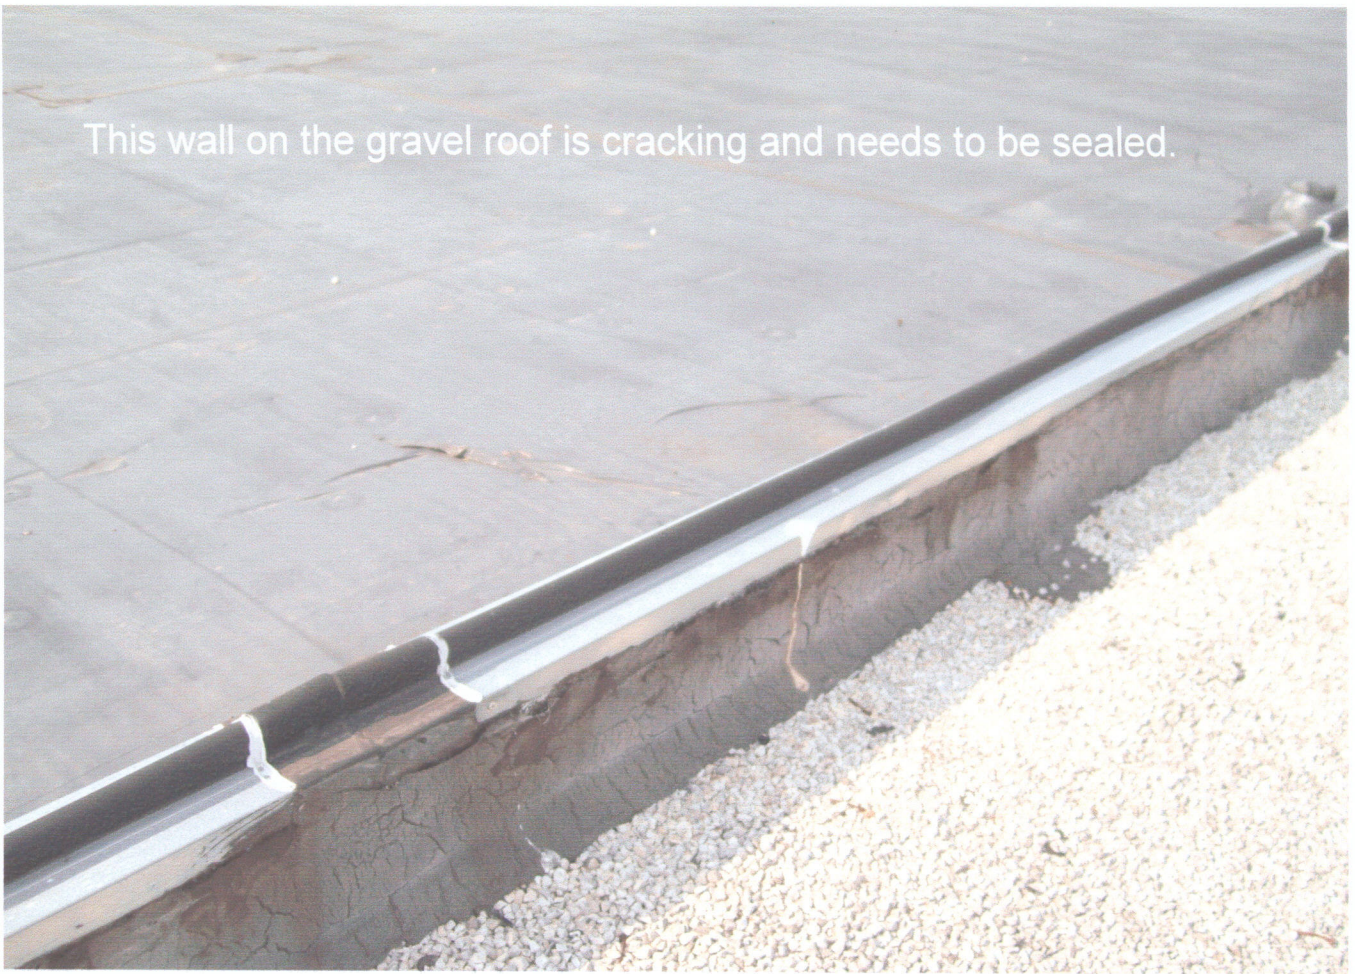
The block wall on the South side of the gravel roof needs waterproofed
